submitted to Composites Science and Technology
March 1987

AN IMAGE ANALYSIS TECHNIQUE FOR EVALUATING INTERNAL DAMAGE IN GRAPHITE/POLYIMIDE FABRIC COMPOSITES

K. Searles¹, J. McCarthy² and M. Kumosa³

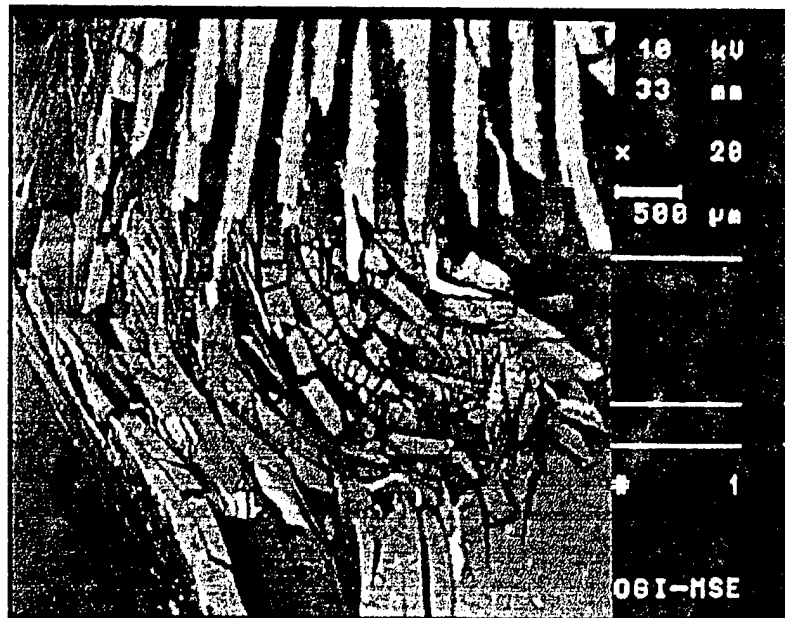
Figure 5

2. The damage zones were associated with significant and permanent out-of-plane deformations (bulging) on the surfaces of the specimens (see Figure 5). It seems that the specimen surface bulging developed just before the "damage trigger".
3. The damage zone morphology was almost identical for all loading angles. It appears, however, that damage zone size was slightly smaller in those samples tested in shear/compression in comparison to the zones developed under biaxial shear/tension loading conditions.

Simultaneously, the ends of the specimen move toward the center and kinking occurs. At some critical point during the loading process, interlaminar cracks develop and propagate, allowing the specimen to bulge outward from the centerline as shown in Figure 5. If the fracture toughness of the interfaces between the layers is low, some of the interlaminar cracks can propagate catastrophically along the specimen causing the load drops.

4. Scanning electron microscope (SEM) micrograph of cracking within the notch root as viewed looking from the top
5. Scanning electron microscope (SEM) micrograph showing the out-of-plane deformation and internal cracking

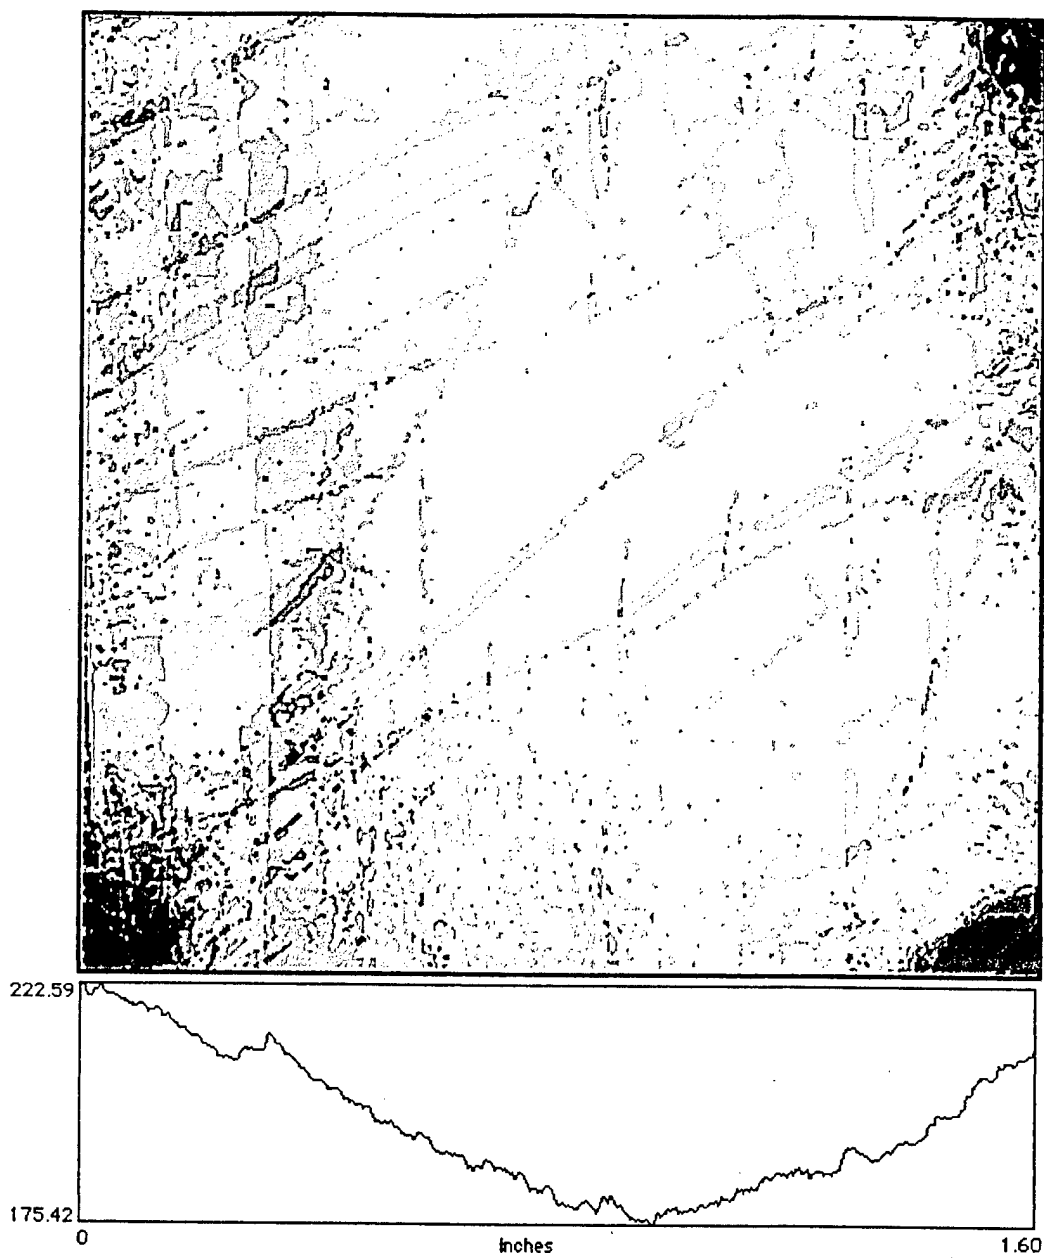
Figure 8

Figures 8 and 9 present two-dimensional maps for the shear tested graphite/polyimide Iosipescu specimen. The damage maps represent damage generated at the specimen center (Figure 8) and an area very close to the notch root (Figure 9), respectively. Each map denotes an approximate area on the specimen of 9 mm². Below each pixel-by-pixel averaged composite map a profile plot is presented showing the relative pixel contrast intensities by average gray values as a function of image width. The profile plot illustrates where the majority of cracks is distributed across each map and gives an indication of the size of cracks compared to the width of the map. From these maps, the location of damage in the examined areas can be estimated. Moreover, the crack propagation directions can also be determined.

It is quite possible that the diagonal perimeters shown on the map represent a combination of intralaminar failures at the fiber bundle-matrix interfaces and failure at weave (warp/fill) undulations or "crimps".

Very little cracking is evident in the longitudinal direction (direction parallel to the long axis of the specimen). Vertical cracks (damage zones) dictated by much larger areas seem to represent the interlaminar failure process between the layers. It is possible that one or several of the vertical cracks could be associated with the load-drops shown in Figure 3. It is assumed that the shearing process forces the bundles to rotate and fail at the undulations as progressive intralaminar damage develops.

It is obvious that the amount of damage generated in the specimen center is significantly higher in comparison with the area close to the notch root. Therefore, it can be concluded that the specimen developed large shear stresses at its center without any stress concentrations present at the roots of the notches. This effect will most likely be observed in the specimens tested under the biaxial shear/tension and shear/compression loading conditions.

8. Two-dimensional map and corresponding profile plot of damaged material center target
9. Two-dimensional map and corresponding profile plot of damaged material notch target

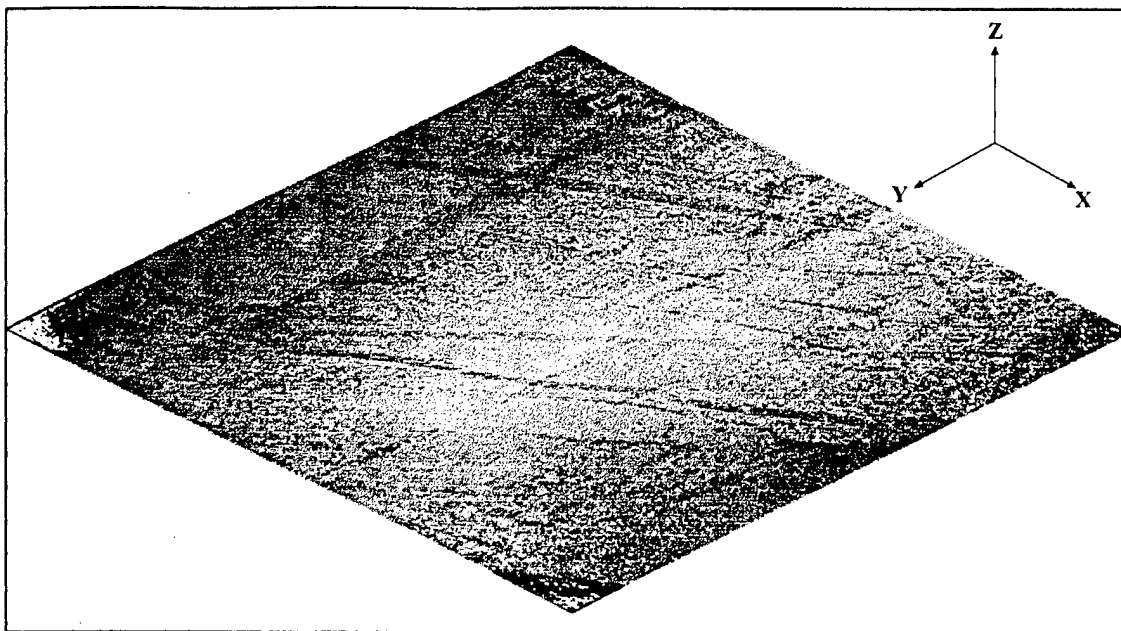
Figure 14a

Figures 14a and 14b show the projected three-dimensional reconstruction of the center and notch SEM targets from an assembly of index pairs 00-04. It can be seen from these figures that damage near the notch is not as pronounced and the majority of cracks follow diagonals similar to patterns where the warp/fill undulations are located. The projections give the illusion of transparency, but they actually represent a compilation of depth and intensity maps derived from the two-dimensional crack-laden stack averages. The darker corner areas are portions of the holes used to align each image from surface to sub-surface in sequence.
